## Upper Mississippi and Illinois Rivers Floodplains Experience Widespread Loss of Forested Areas

### Longer periods of flooding, human modifications to the river, and other environmental changes contribute to the decline of floodplain forests.

This is a summary of the long-term trends in floodplain forests observed via monitoring from 1989 to 2010 as reported in the [Ecological Status and Trends of the Upper Mississippi and Illinois Rivers](#).

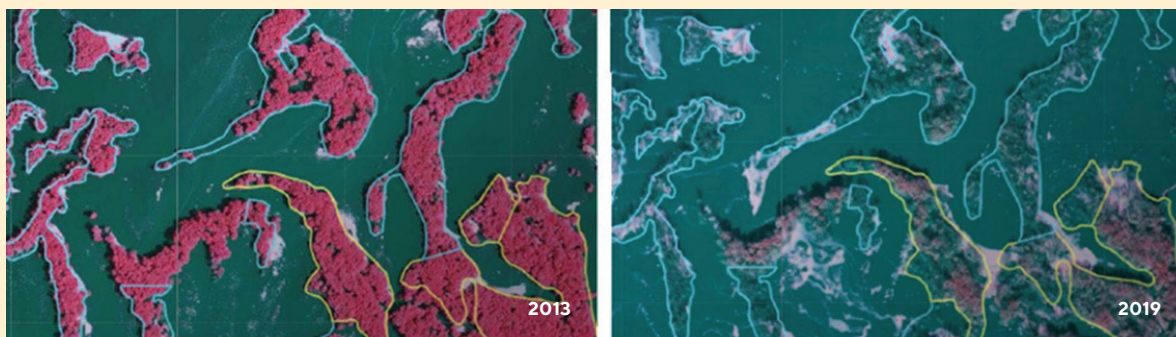
*To the Left:* Aerial imagery of historic 2019 flooding reveals further impacts on the floodplain forest community. Infrared imagery shows the health of trees in the floodplain: live trees are red and dead trees are green. Outlines show a reduction in live trees of 50% in blue and 90% in yellow. *Photos courtesy of Andy Meier, USACE*

Partners who manage forest areas map floodplain forests to assess the quality and quantity of habitat for wildlife that use floodplains as their homes or as migratory corridors. The maps below show impacts from the record 2019 flood and reveal additional floodplain forest loss in parts of the river. This recent flood event was not captured in the report.
